TEA FIRE SEWER STUBS

January 2009

TEA FIRE LATERAL
ABANDONMENT PROJECT

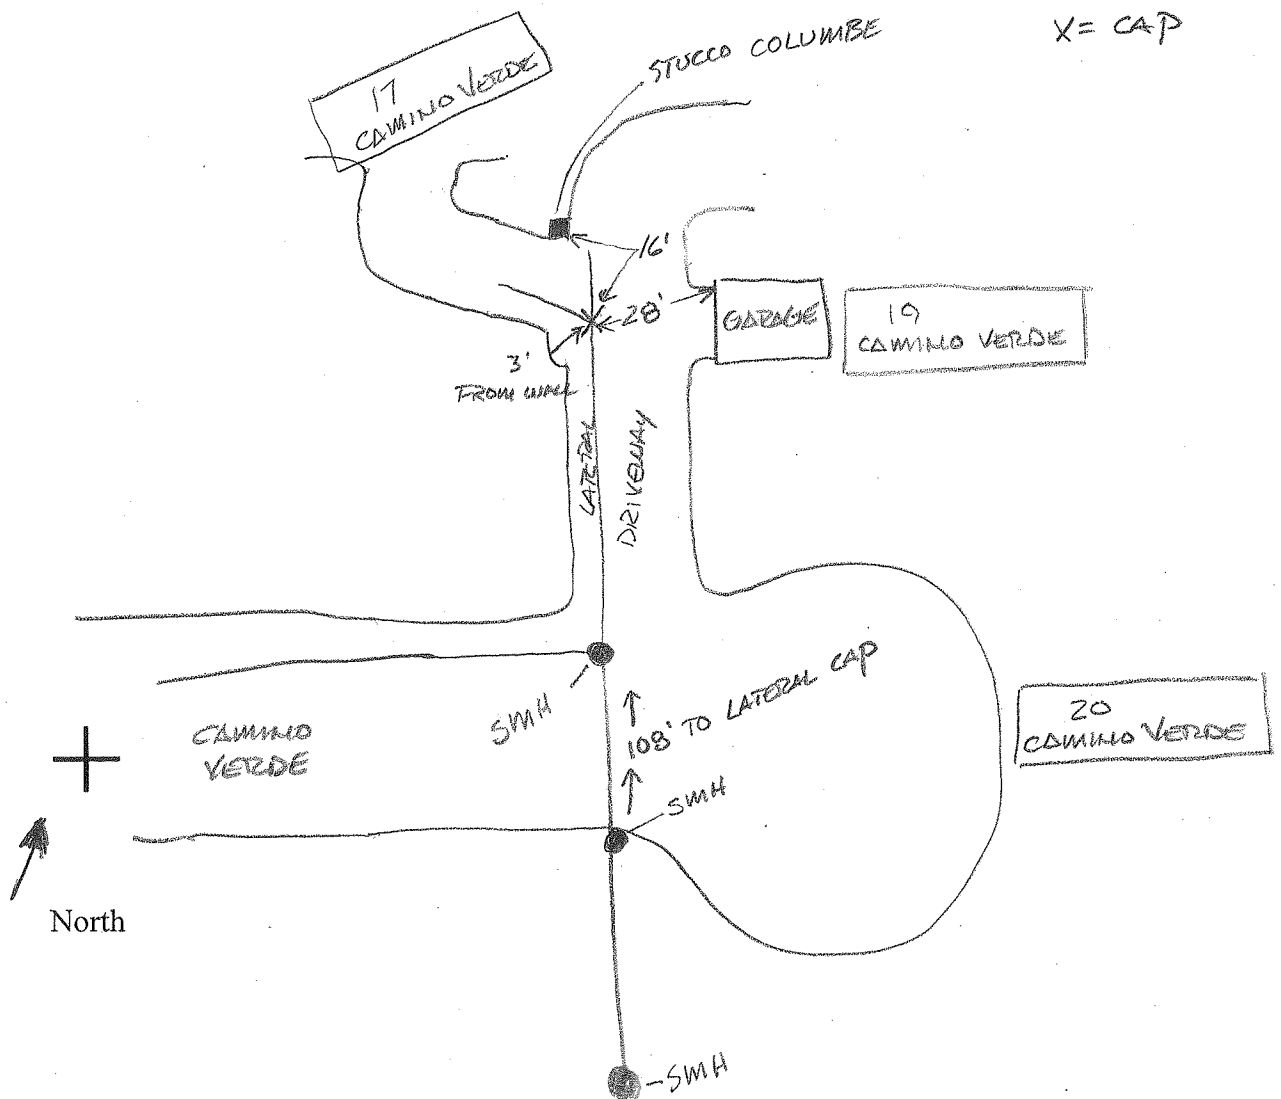
- Date: 1-5-09
- Property Address: 17 CAMINO VERDE
- Location/Address of actual excavation (also see diagram attached):
- Size & material type of sewer main: N/A
- Size & material type of lateral: 4" ABS
- Depth of Wye connection: 18"
- Distance of lateral from centerline of downstream manhole: 108
- Excavation dimensions:
- Brief description of the site (utility conflict/traffic/soil type/other issues):

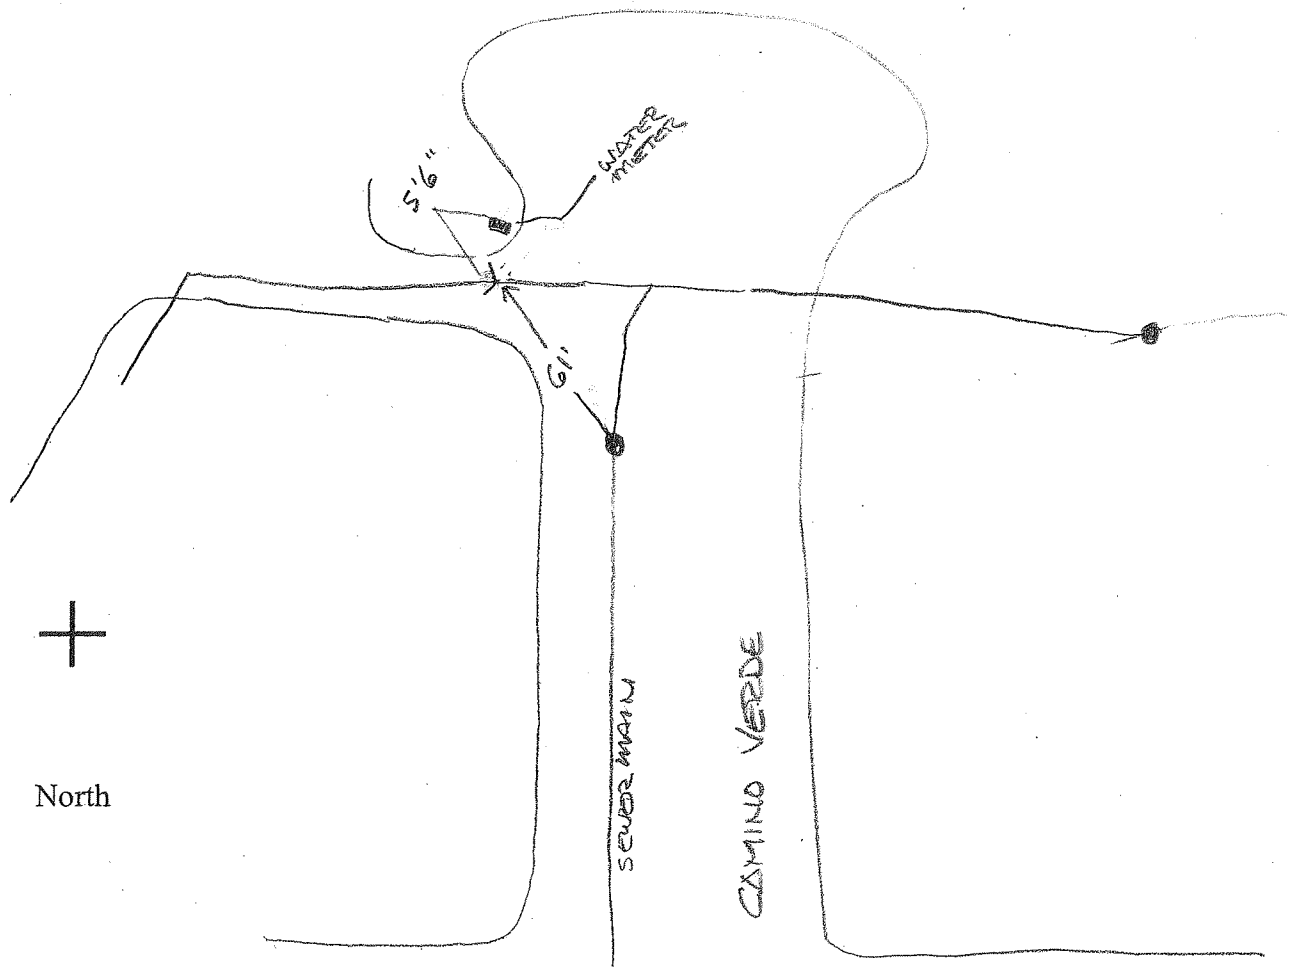
- Date: 12-31-08
- Property Address: 19 CAMINO VERDE
- Location/Address of actual excavation (also see diagram attached):
- Size & material type of sewer main:
- Size & material type of lateral: 4" ABS
- Depth of Wye connection: 3'
- Distance of lateral from centerline of ^{UPSTREAM} ~~downstream~~ manhole: 61'
- Excavation dimensions:
- Brief description of the site (utility conflict/traffic/soil type/other issues):

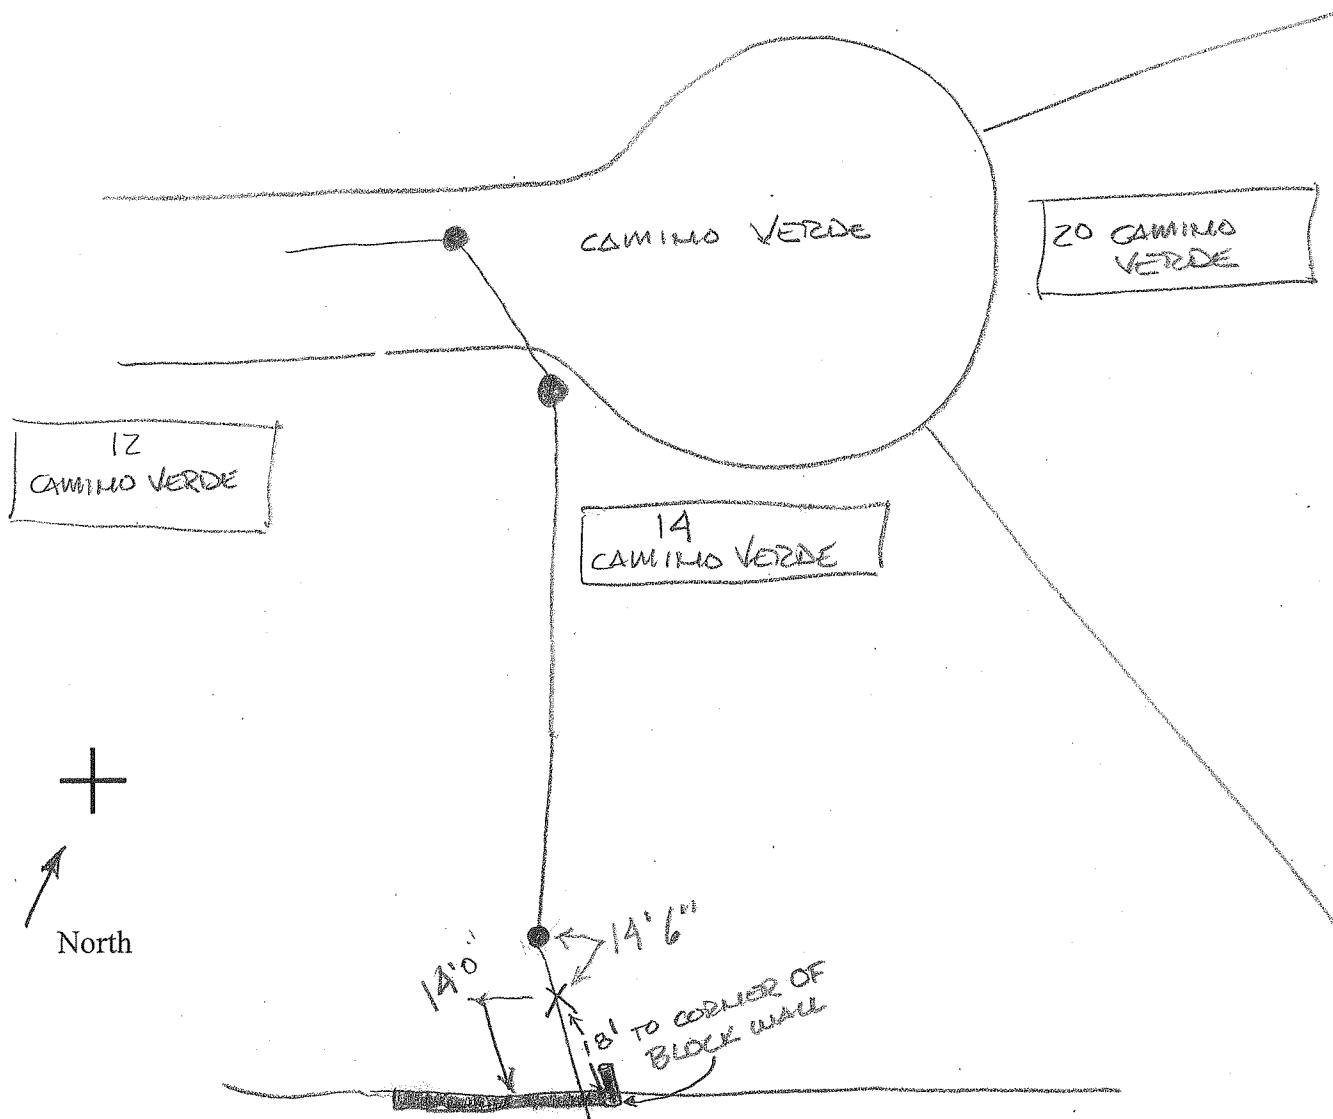
- **Date:** 1-5-09
- **Property Address:** 20 CAMINO VERDE
- **Location/Address of actual excavation (also see diagram attached):**
- **Size & material type of sewer main:**
- **Size & material type of lateral:**
- **Depth of Wye connection:** 2'
- **Distance of lateral from centerline of downstream manhole:**
- **Excavation dimensions:**
- **Brief description of the site (utility conflict/traffic/soil type/other issues):**

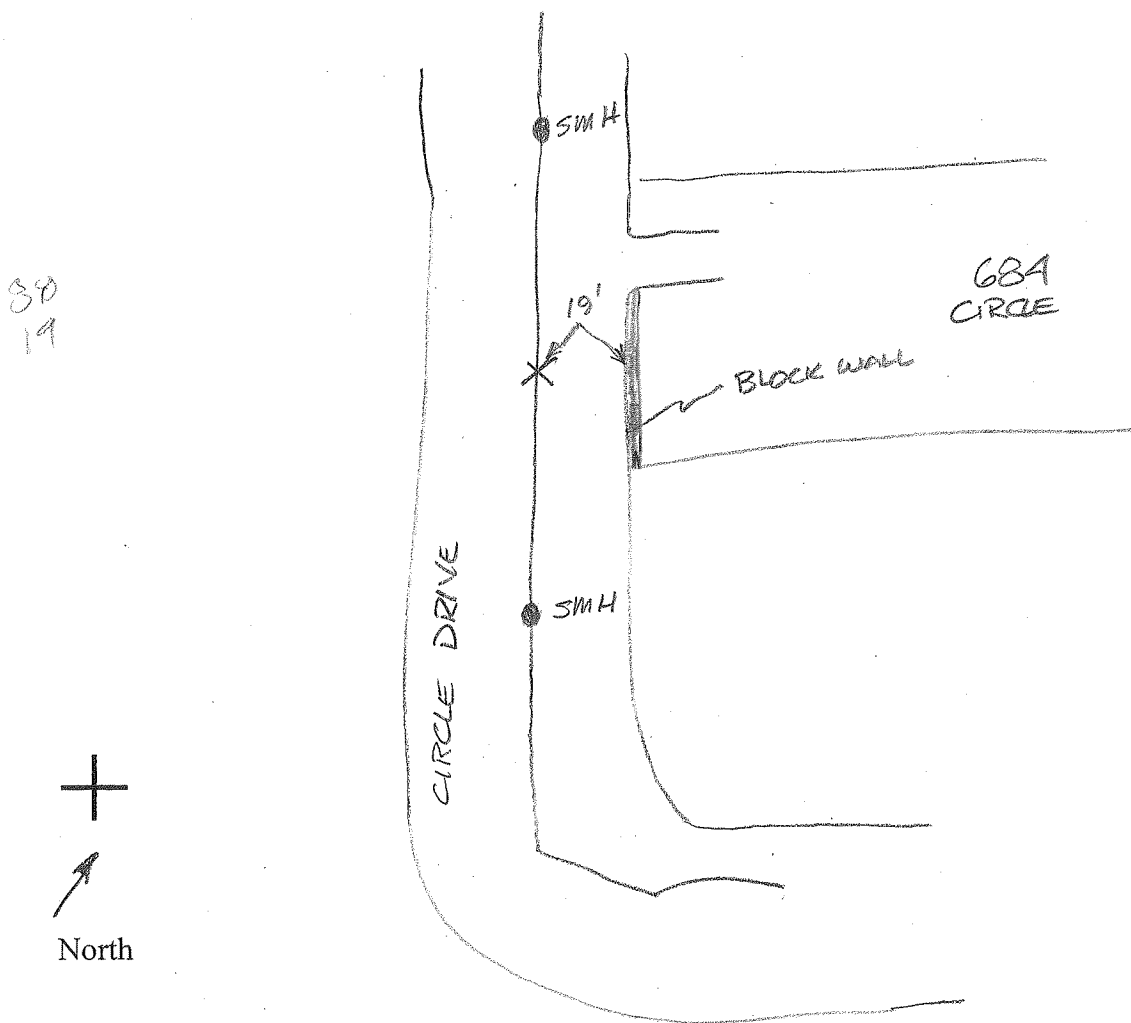
- Date: 1-5-09
- Property Address: 684 CIRCLE
- Location/Address of actual excavation (also see diagram attached):
- Size & material type of sewer main:
- Size & material type of lateral:
- Depth of Wye connection: 5'
- Distance of lateral from centerline of downstream manhole: 88'
- Excavation dimensions: 2x3
- Brief description of the site (utility conflict/traffic/soil type/other issues): None

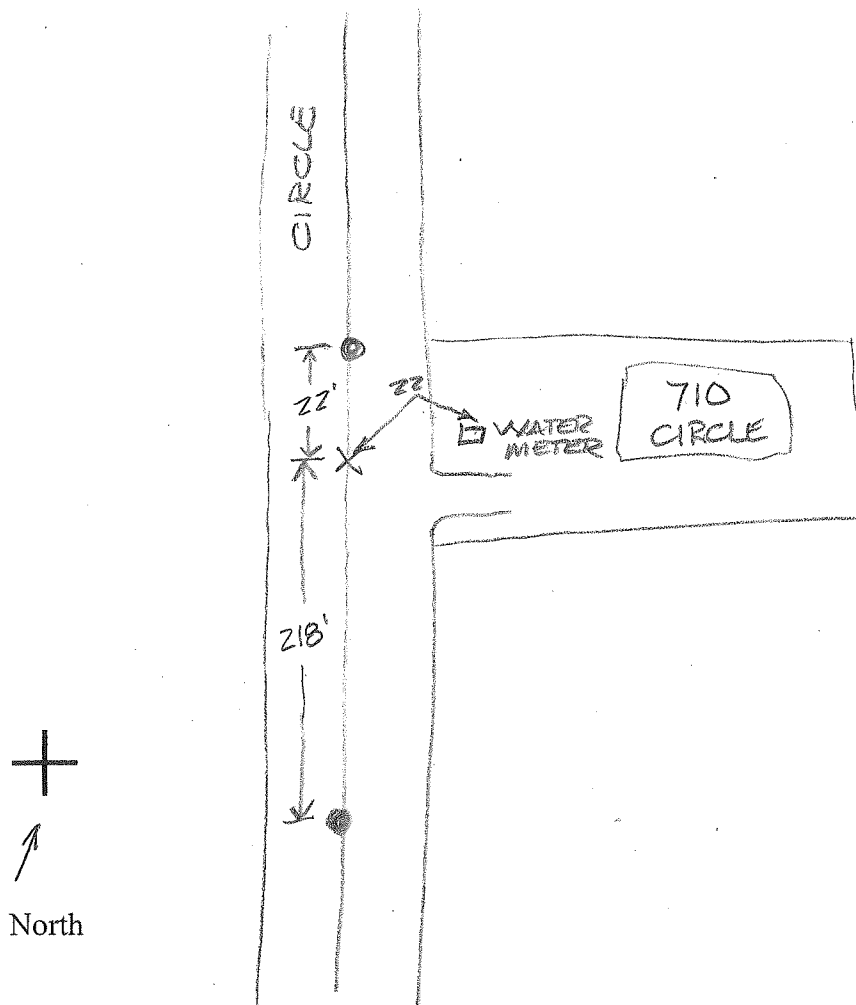
- Date: 1-5-09
- Property Address: 710 CIRCLE
- Location/Address of actual excavation (also see diagram attached):
- Size & material type of sewer main:
- Size & material type of lateral: 4"
- Depth of Wye connection: 5'
- Distance of lateral from centerline of downstream manhole: 218'
- Excavation dimensions: 2x4
- Brief description of the site (utility conflict/traffic/soil type/other issues): NONE

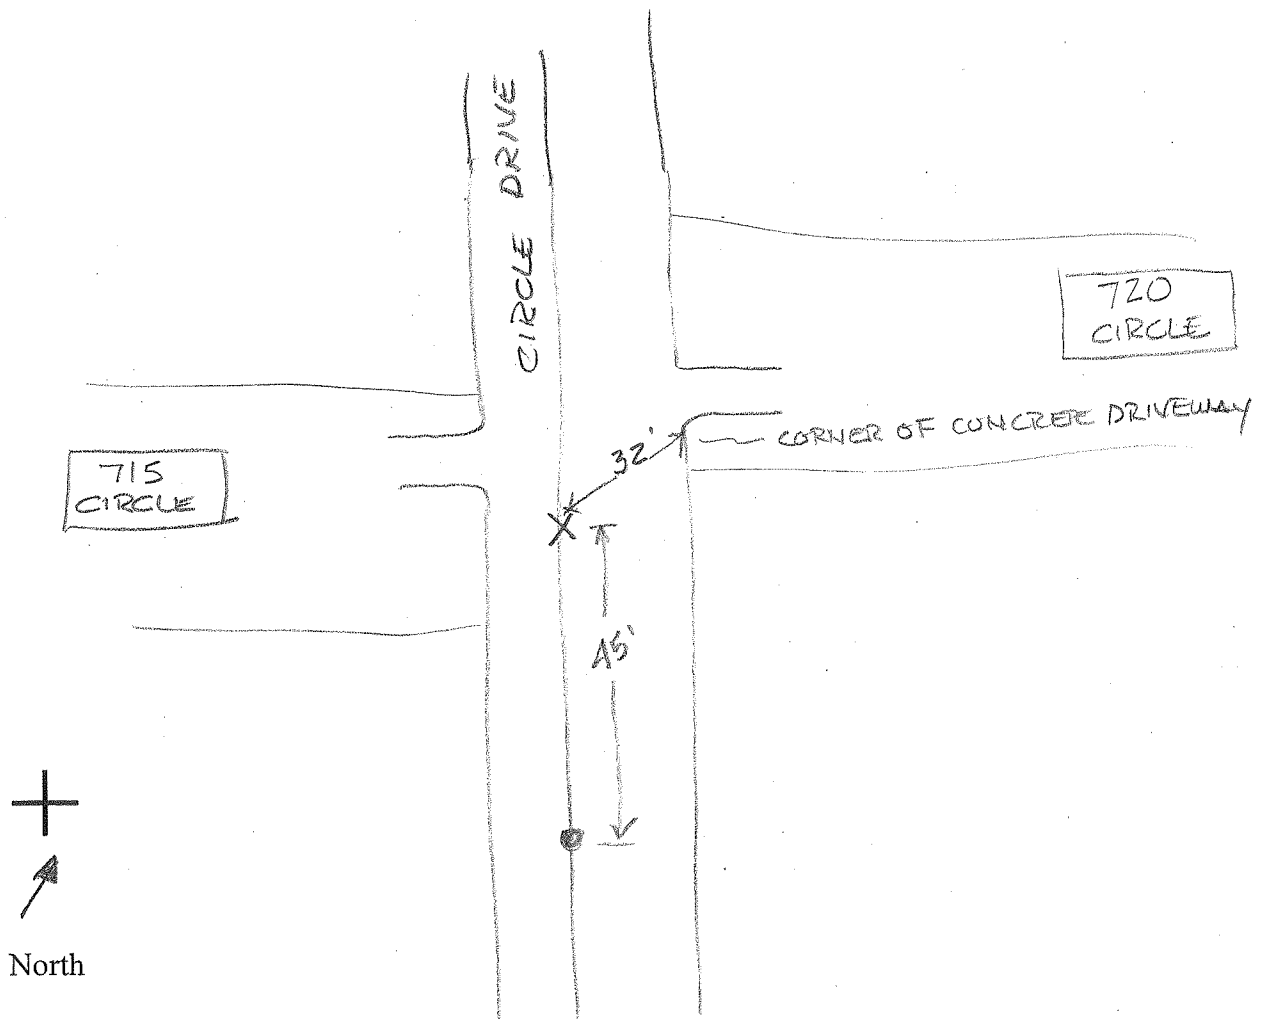
- Date: 1-5-09
- Property Address: 715 circle
- Location/Address of actual excavation (also see diagram attached):
- Size & material type of sewer main:
- Size & material type of lateral: 4"
- Depth of Wye connection: 5'
- Distance of lateral from centerline of downstream manhole: 45'
- Excavation dimensions: 2x4
- Brief description of the site (utility conflict/traffic/soil type/other issues): NONE

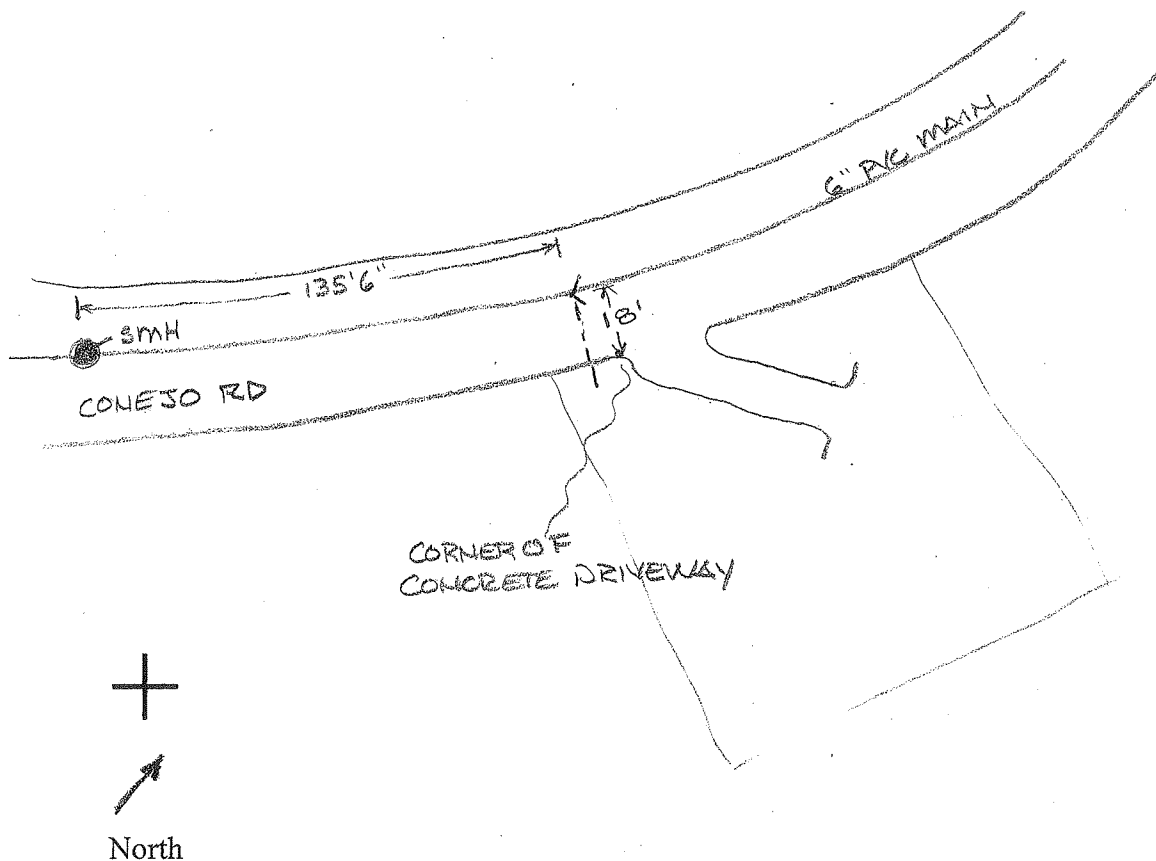
- Date: 12-19-08
- Property Address: 217 CONESO
- Location/Address of actual excavation (also see diagram attached): SAME
- Size & material type of sewer main: 6" PVC w/ PVC SADDLE
- Size & material type of lateral: 4" ABS
- Depth of Wye connection: 3'6"
- Distance of lateral from centerline of downstream manhole: 135'6"
- Excavation dimensions: 5x2
- Brief description of the site (utility conflict/traffic/soil type/other issues): U/G NEARBY

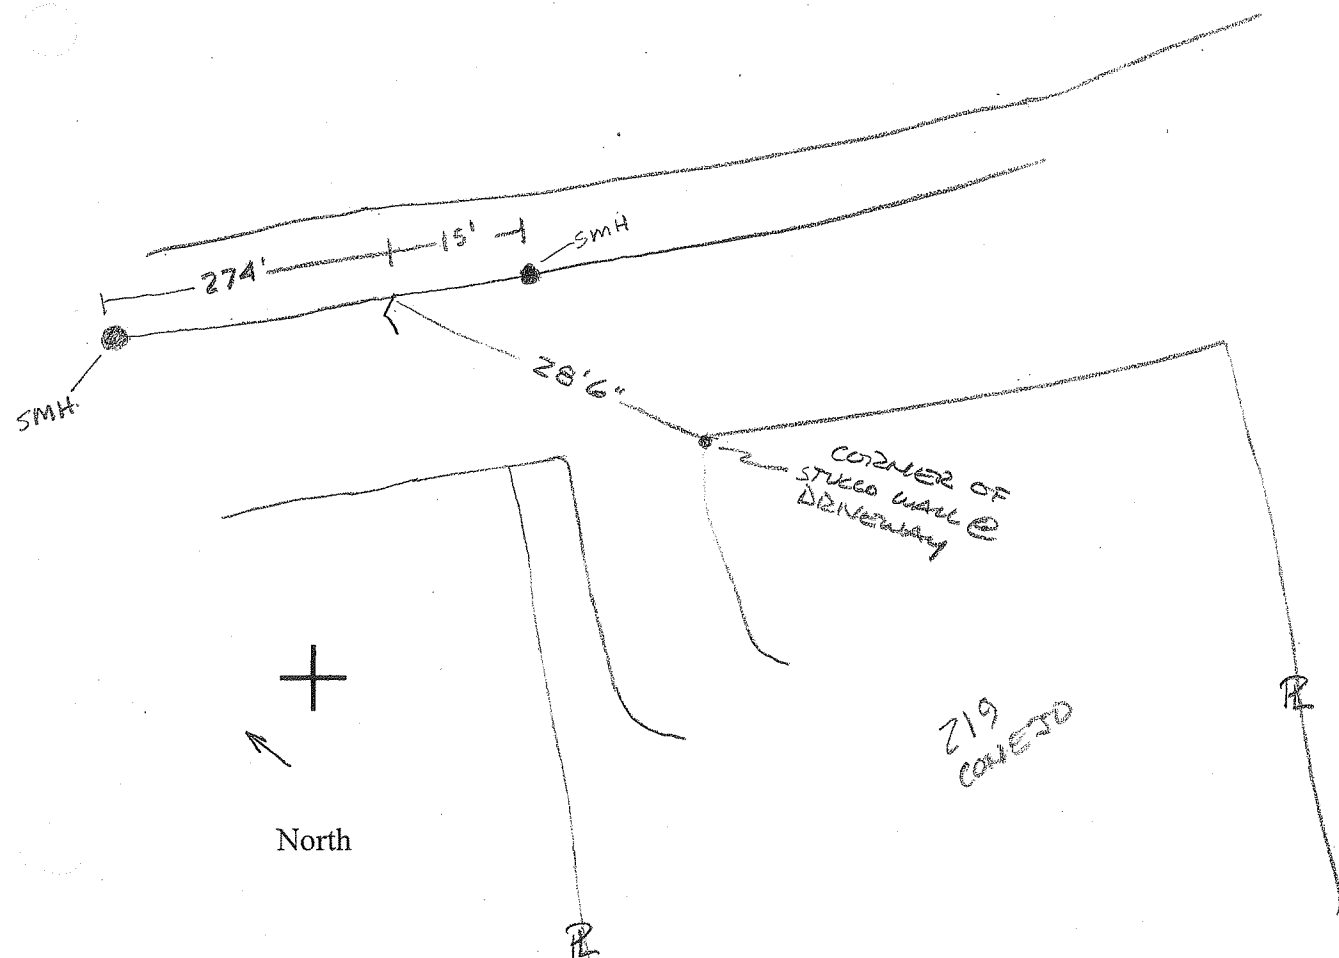
- Date: 12-23-08
- Property Address: 219
- Location/Address of actual excavation (also see diagram attached): SAME
- Size & material type of sewer main: 6" PVC
- Size & material type of lateral: 4" ABS
- Depth of Wye connection: 3' 6"
- Distance of lateral from centerline of downstream manhole: 274'
- Excavation dimensions: 4' X 3'
- Brief description of the site (utility conflict/traffic/soil type/other issues):

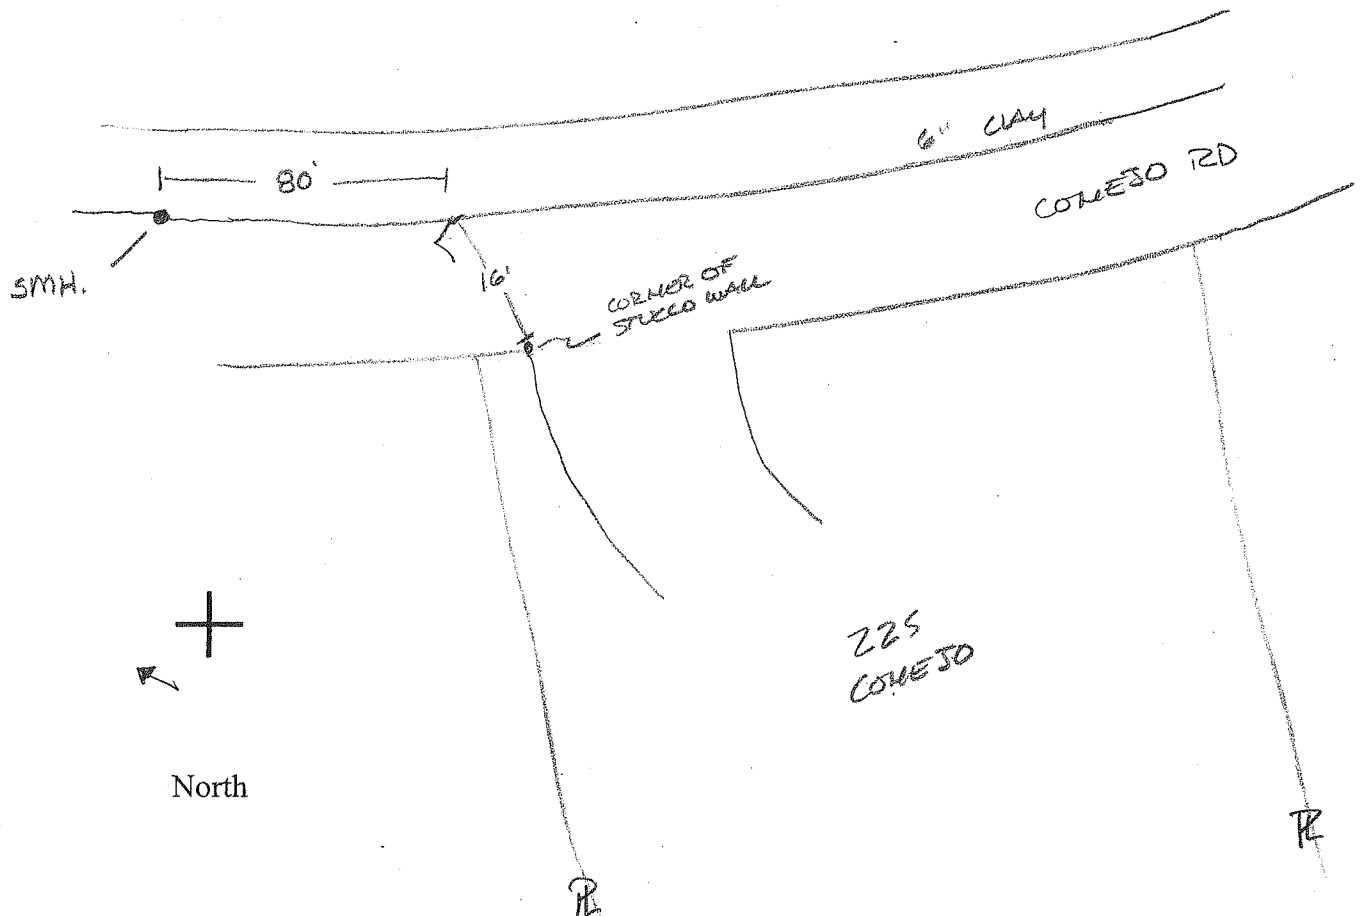
- Date: 12-19-08
- Property Address: 225 CONESO
- Location/Address of actual excavation (also see diagram attached): SAME
- Size & material type of sewer main:
- Size & material type of lateral:
- Depth of Wye connection:
- Distance of lateral from centerline of downstream manhole:
- Excavation dimensions:
- Brief description of the site (utility conflict/traffic/soil type/other issues):

80' FROM D.S. SMH
 16' FROM CORNER OF STUCCO
 WALL @ EAST SIDE OF
 DRIVEWAY.

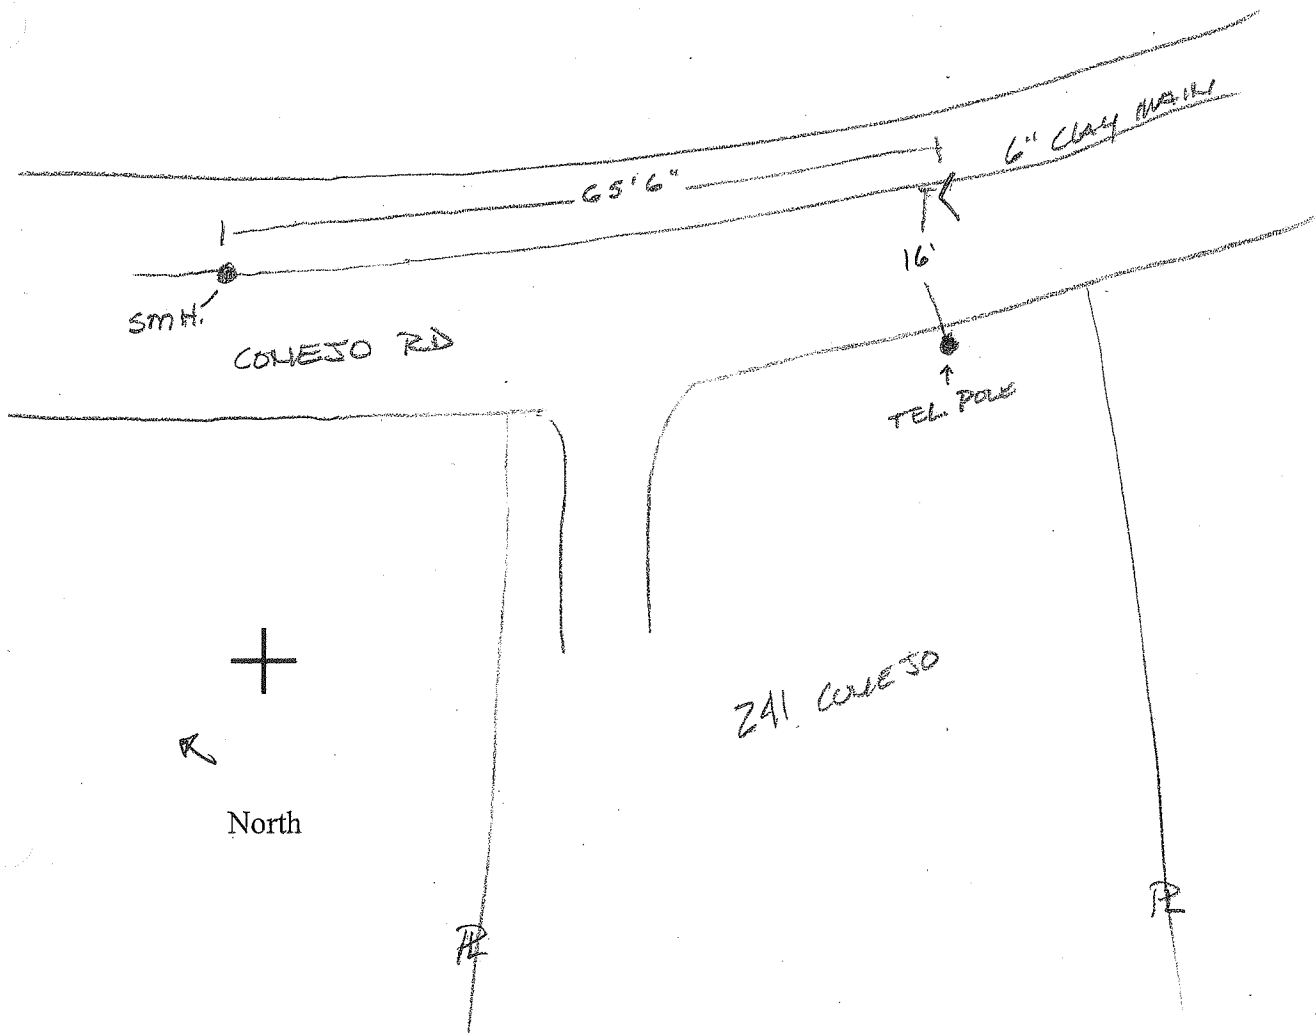
- Date: 12-19-08
- Property Address: 241 CONEJO
- Location/Address of actual excavation (also see diagram attached):
- Size & material type of sewer main:
- Size & material type of lateral:
- Depth of Wye connection:
- Distance of lateral from centerline of downstream manhole:
- Excavation dimensions:
- Brief description of the site (utility conflict/traffic/soil type/other issues):

65'6" FROM D.S. SMH
16' FROM TELEPHONE POLE

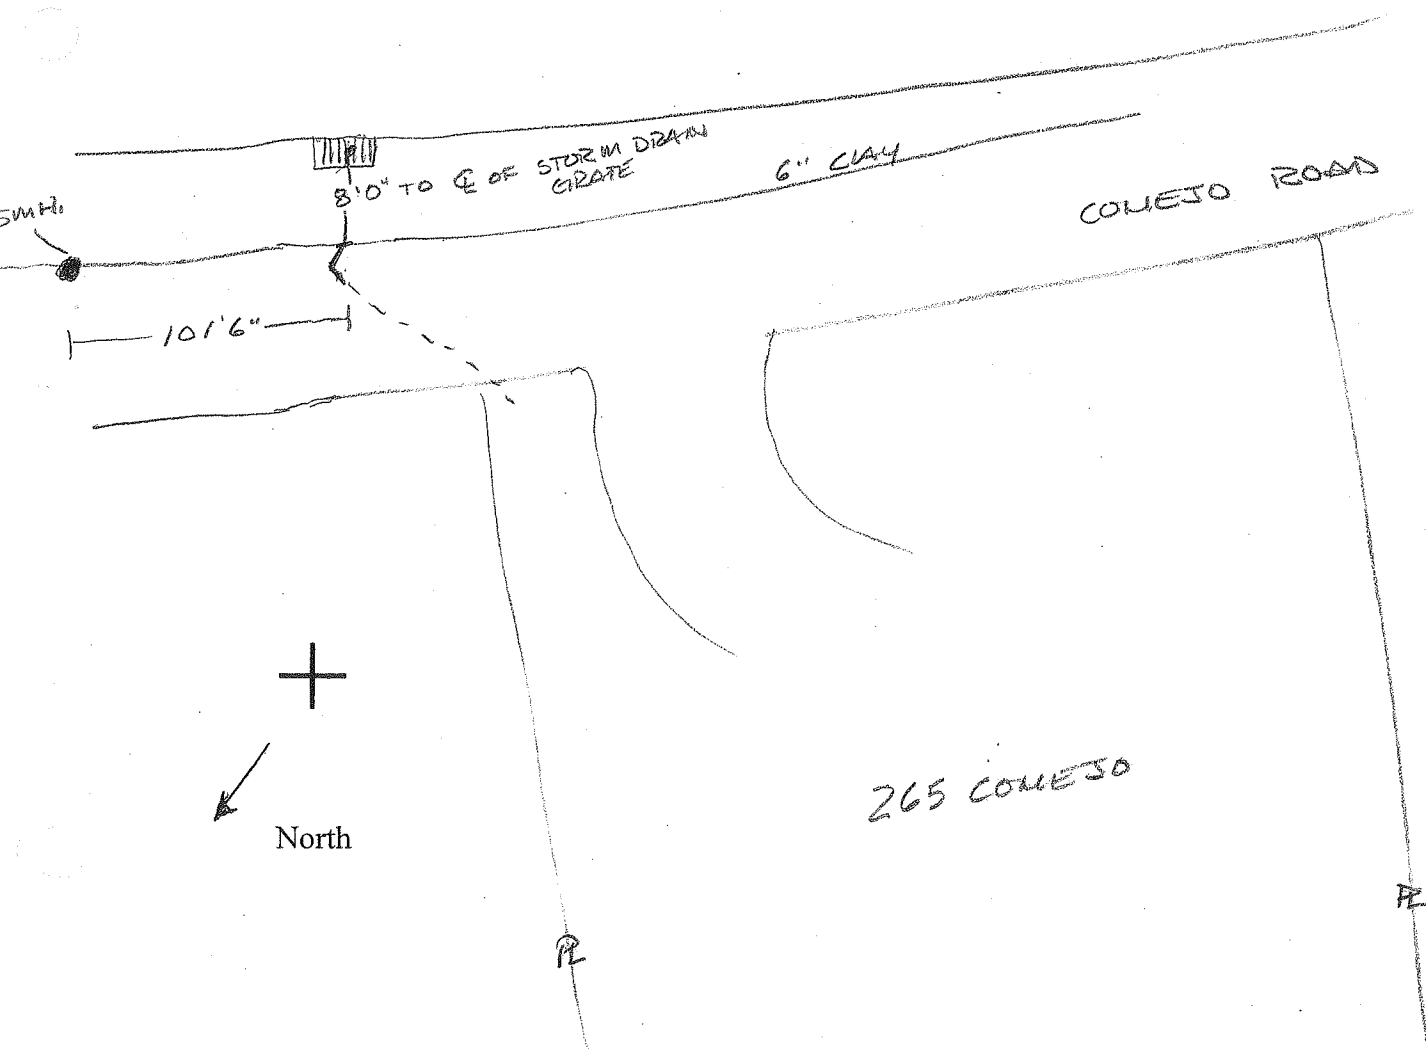
- Date: 12-23-08
- Property Address: 265 CONEJO
- Location/Address of actual excavation (also see diagram attached): SAME
- Size & material type of sewer main: UNKNOWN - PLASTIC WYE
- Size & material type of lateral: 4" SDR
- Depth of Wye connection: 4'6"
- Distance of lateral from centerline of downstream manhole: 101'6"
- Excavation dimensions:
- Brief description of the site (utility conflict/traffic/soil type/other issues):

101'6" FROM D.S. SMH
 8'0" FROM C OF STORM DRAIN GRATE

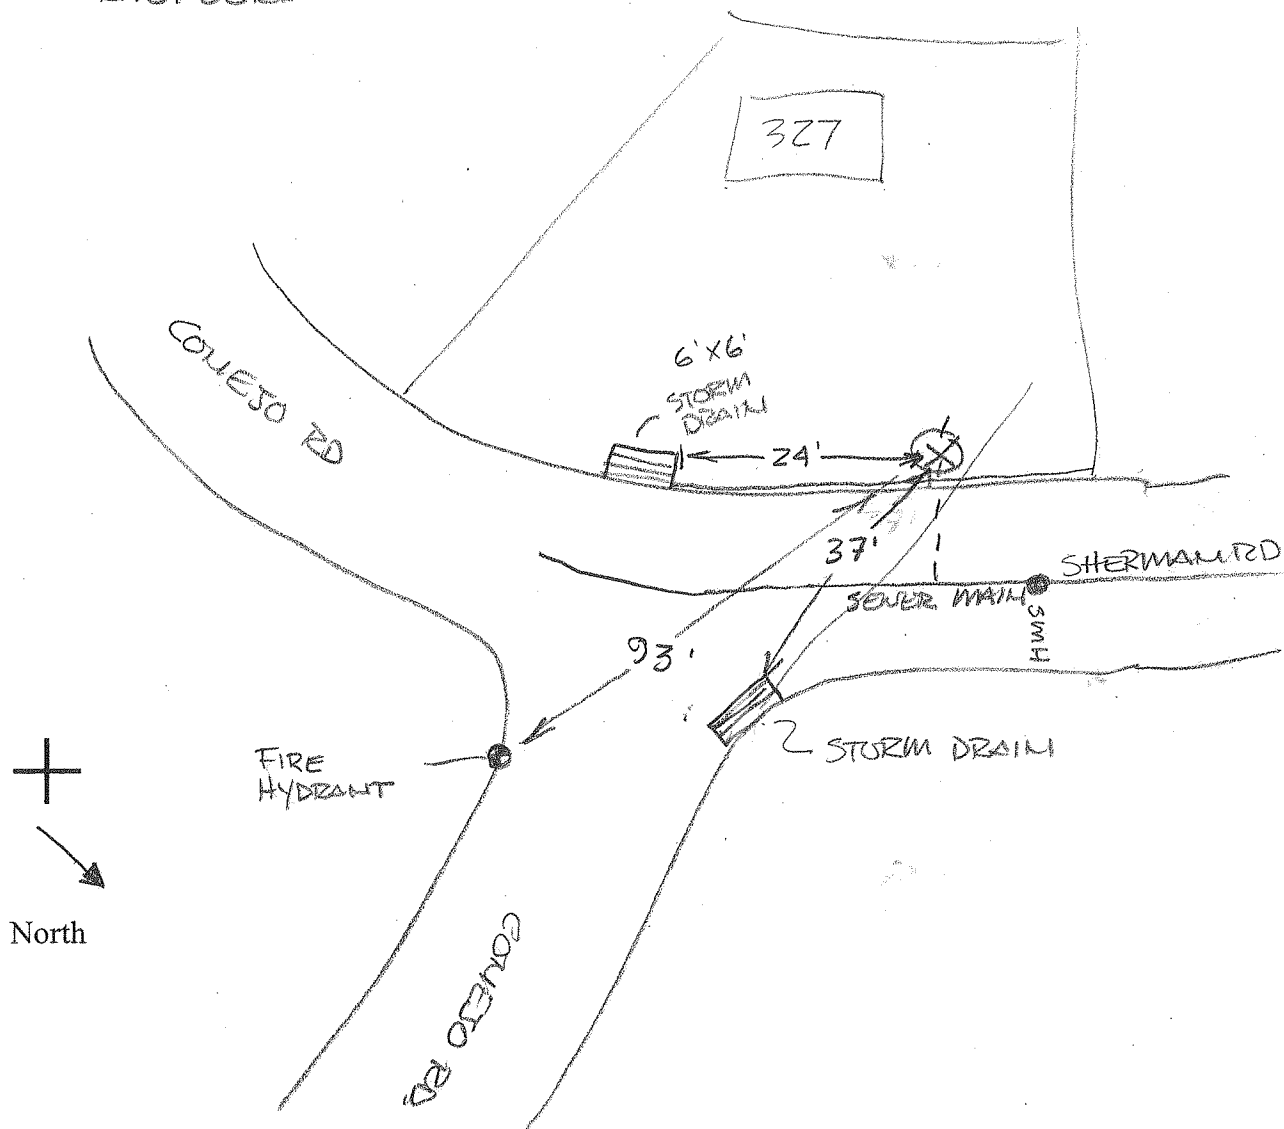
- Date: 1-13-09
- Property Address: 327 CONEJO RD
- Location/Address of actual excavation (also see diagram attached):
- Size & material type of sewer main:
- Size & material type of lateral: 4" SLIP LINED
- Depth of ^{PLUG}Wye connection: 6'
- Distance of lateral from centerline of downstream manhole: N/A
- Excavation dimensions: 3x4
- Brief description of the site (utility conflict/traffic/soil type/other issues): LATERAL ON SHERMAN RD.

⊗ = PLUG - 3' BEHIND
Δ.C. CURB

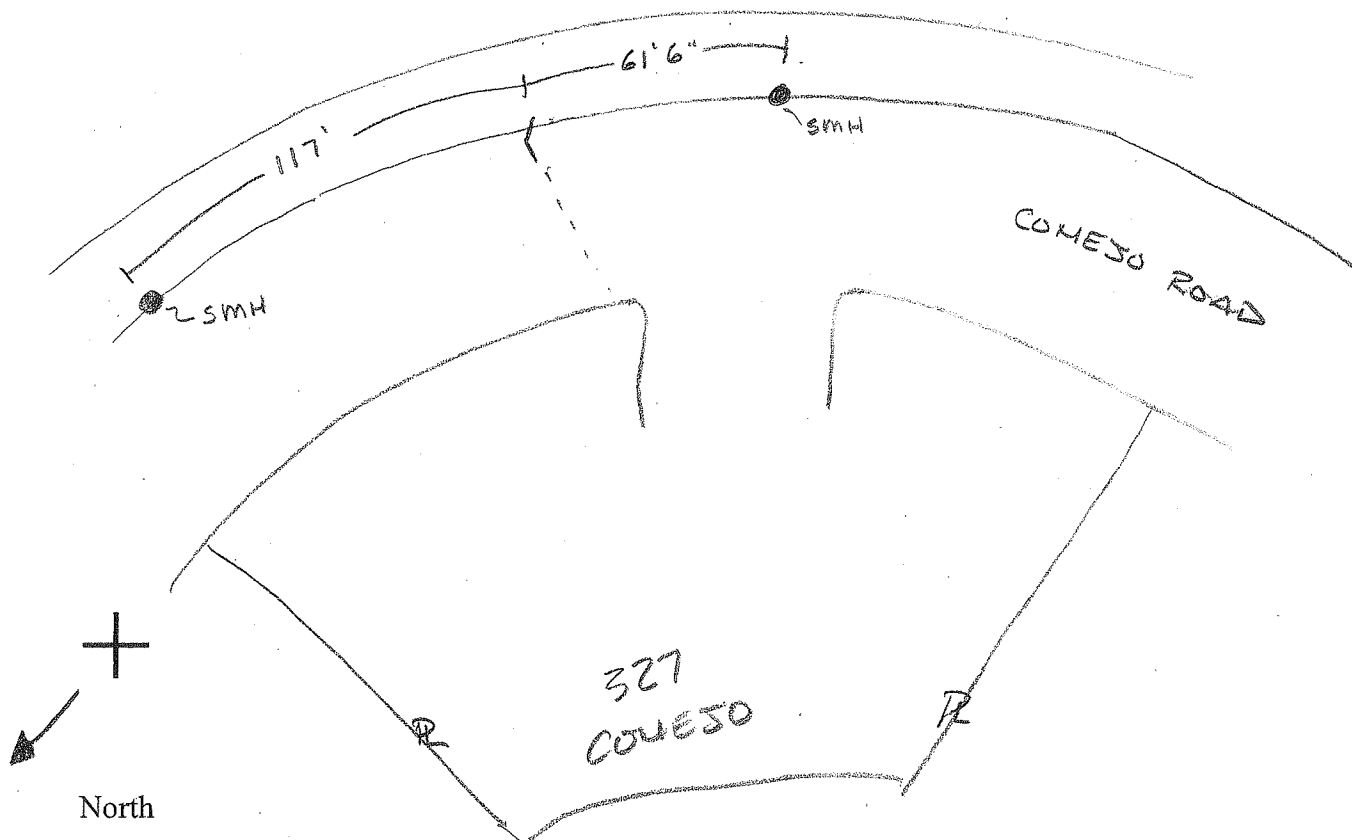
- Date: 12-23-08
- Property Address: 327 CONESO
- Location/Address of actual excavation (also see diagram attached): SAME
- Size & material type of sewer main: 6" CLAY
- Size & material type of lateral: 4" CLAY
- Depth of Wye connection: 7'0"
- Distance of lateral from centerline of downstream manhole: 117'
- Excavation dimensions: 3' X 5'
- Brief description of the site (utility conflict/traffic/soil type/other issues): NONE

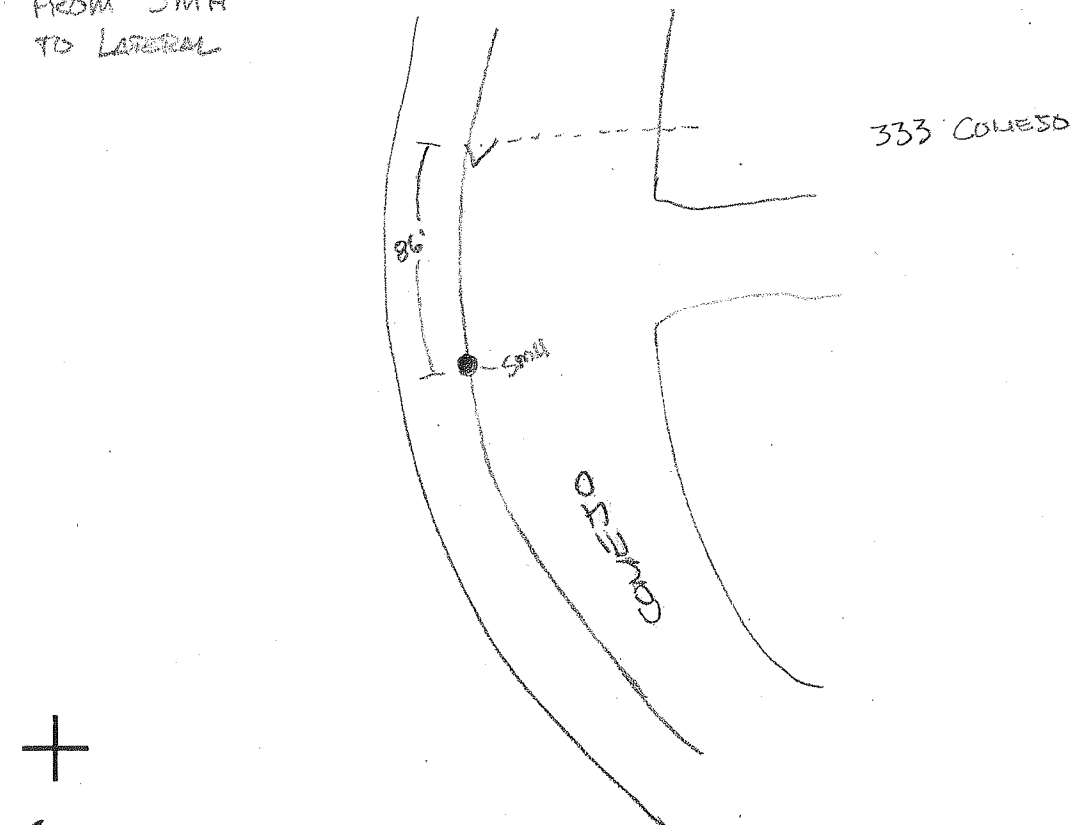
- Date: 12-23-08
- Property Address: 333 COMEJO
- Location/Address of actual excavation (also see diagram attached):
- Size & material type of sewer main: 6" VCP
- Size & material type of lateral: 4" ABS
- Depth of Wye connection: 6'
- Distance of lateral from centerline of downstream manhole: 86'
- Excavation dimensions: 3' x 4'
- Brief description of the site (utility conflict/traffic/soil type/other issues): NONE

86' FROM SMH
TO LATERAL

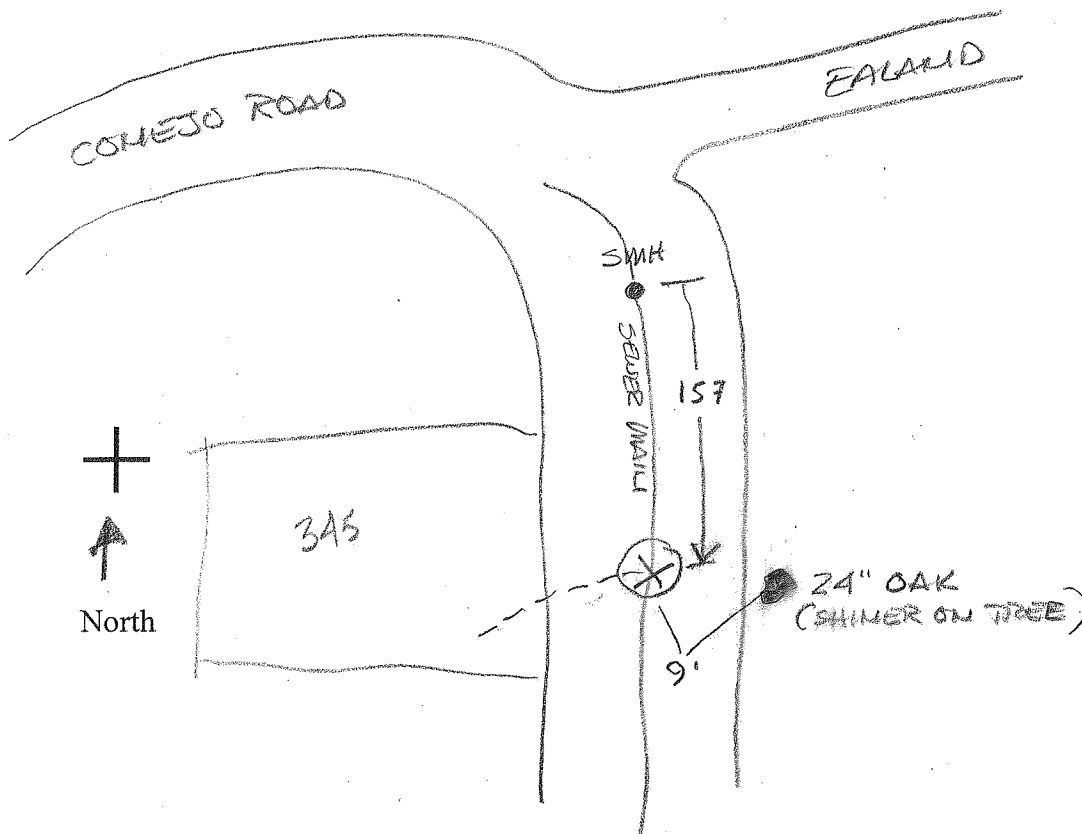
- Date: 1-13-09
 - Property Address: 345 CONEJO RD.
 - Location/Address of actual excavation (also see diagram attached):
 - Size & material type of sewer main: N/A
 - Size & material type of lateral: 4" CLAY
 - Depth of ^{PLUG}Wye connection: 4' 10"
 - Distance of lateral from centerline of downstream manhole: 157'
 - Excavation dimensions: 2x4
 - Brief description of the site (utility conflict/traffic/soil type/other issues): WYE "BELL" IS CRACKED @ MAIN LINE DUE TO ROOT DAMAGE
- (X) = PLUG

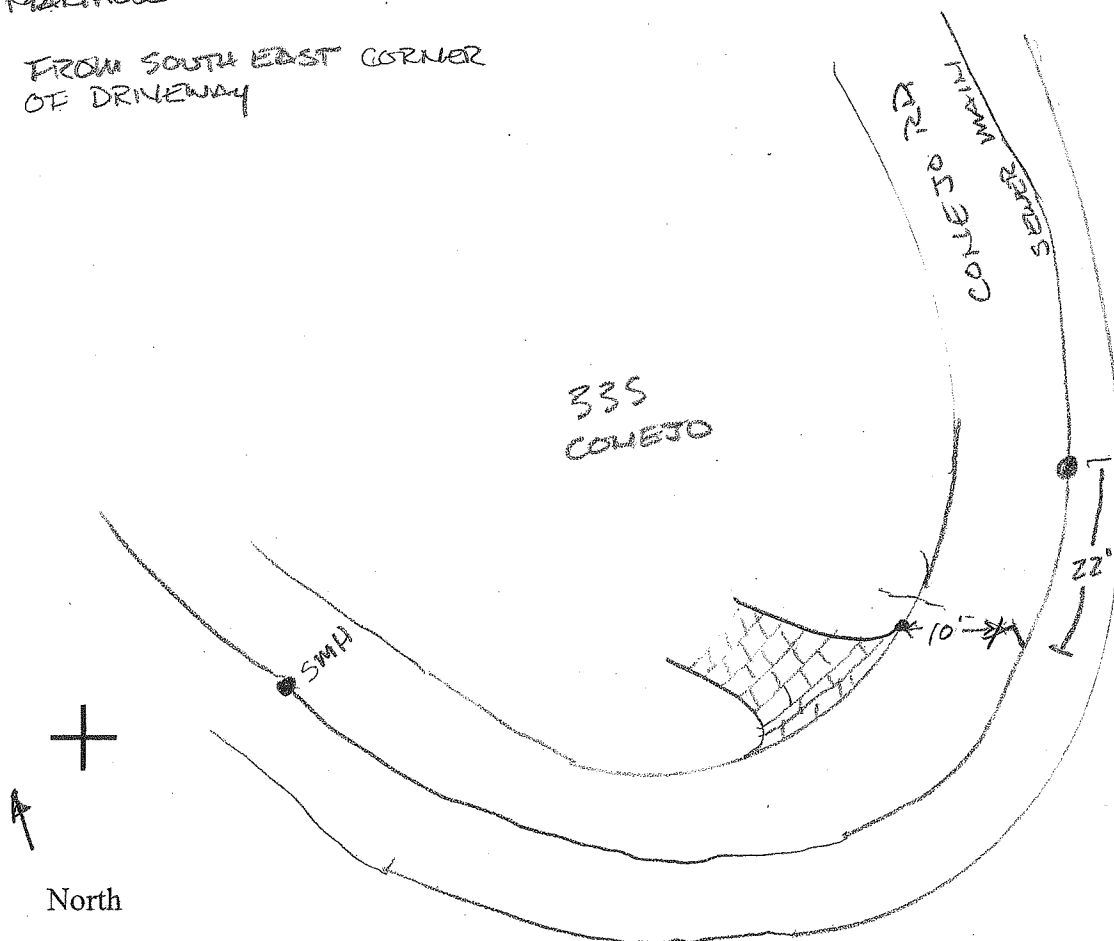
- Date: 12-24-08
- Property Address: 357 COWETO
- Location/Address of actual excavation (also see diagram attached): SAME
- Size & material type of sewer main: 6" clay
- Size & material type of lateral: 4" ABS
- Depth of Wye connection: 5'
- Distance of lateral from centerline of downstream manhole: 22'
- Excavation dimensions: 2 x 4
- Brief description of the site (utility conflict/traffic/soil type/other issues): NONE

22' FROM DOWNSTREAM
MANHOLE

10' FROM SOUTH EAST CORNER
OF DRIVEWAY

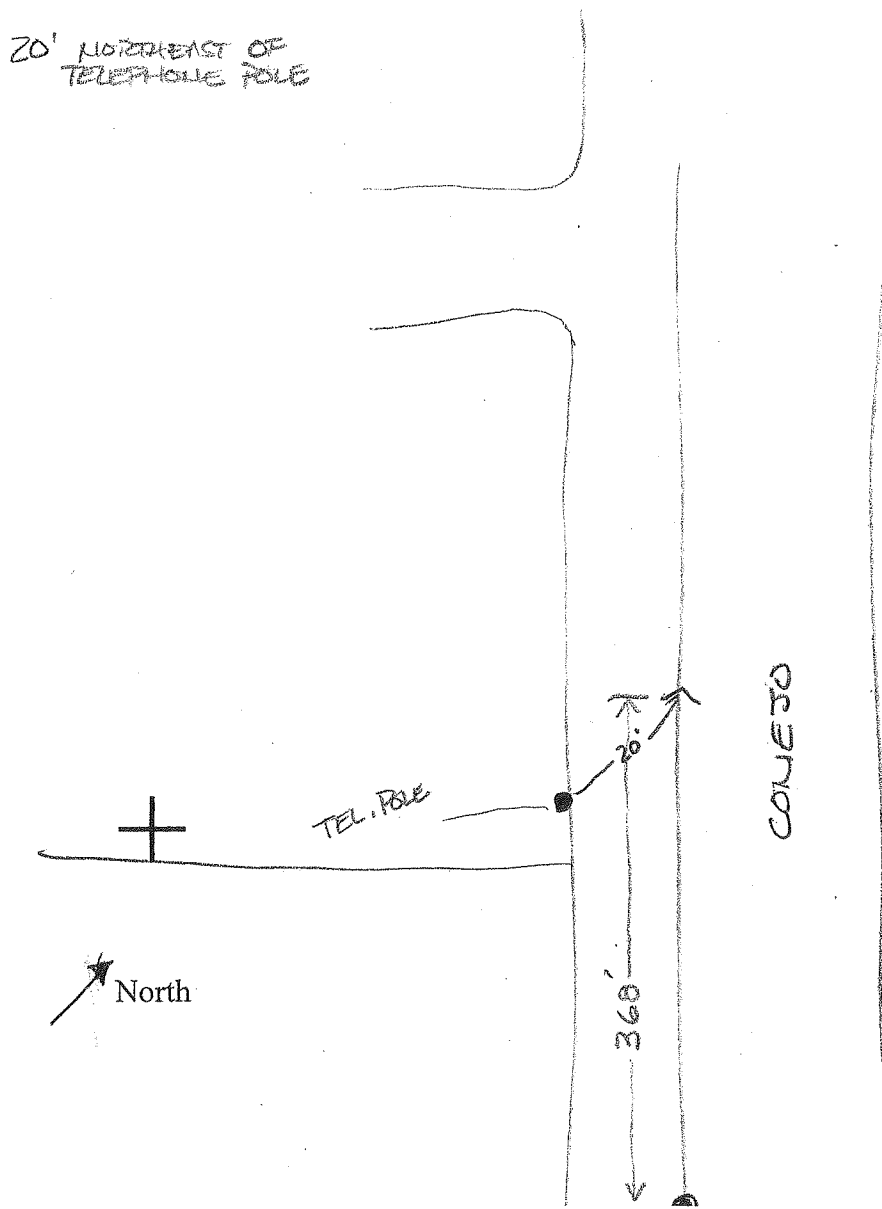
- Date: 12-29-08
- Property Address: 428 CONEJO
- Location/Address of actual excavation (also see diagram attached):
- Size & material type of sewer main:
- Size & material type of lateral: 4" CLAY
- Depth of Wye connection:
- Distance of lateral from centerline of downstream manhole: 368' FROM D.S. SMH
- Excavation dimensions:
- Brief description of the site (utility conflict/traffic/soil type/other issues):
